## Derailment Investigation

On the 26<sup>th</sup> October 2005, a passenger train derailed underground on a sharp curve on the approach to Liverpool Central underground station. Thankfully, the incident occurred at low speed and there were no injuries sustained. Damage to both rolling stock and infrastructure was minor, but the 119 passengers on-board had to be evacuated by the emergency services.

The subsequent derailment investigation was undertaken by the UK Rail Accident Investigation Branch (RAIB) supported by DeltaRail, then operating as AEA Technology Rail. VAMPIRE® Pro was used to replicate the derailment mechanism and then provided a cost-effective tool to establish which remedial measure(s) would be most effective at preventing future derailments at this and other similar sites.

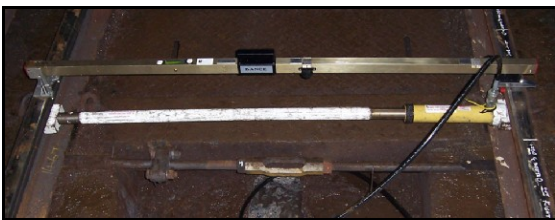
The evidence on-site indicated that the initial derailment occurred when inner wheel of the derailed axle dropped between the rails. This then forced the outer wheel to flange climb up and over the outer rail. The outer rail showed a high degree of side wear consistent with high lateral contact forces and the general condition of the track suggested that gauge spread was the most likely cause.

DeltaRail therefore surveyed the track geometry in the vicinity of the derailment and measured the level of lateral restraint provided by the rails using a gauge spreading bar (shown below):

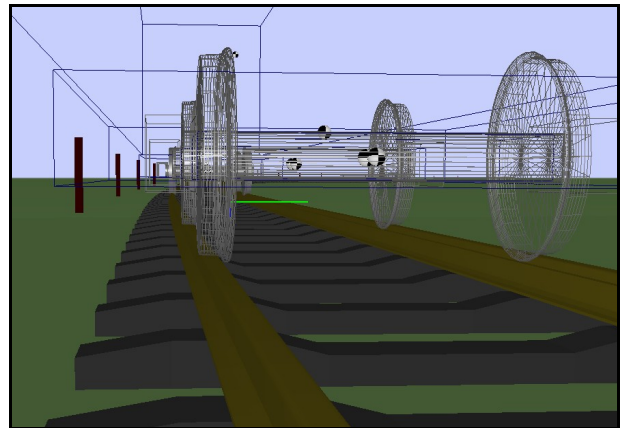
The initial VAMPIRE® Pro analysis demonstrated that the lateral track forces generated by the passage of a single wheelset would not have been enough to enable it to drop between the rails:

However, the progressive widening effect of successive axles was predicted to cause the gauge to widen by 50mm. Given the already wide static gauge, this would have been sufficient to cause the derailment.

- modifications were made to the vehicle model to improve its curving performance, but it was concluded that only major changes to its design would prevent derailment
- an evaluation of vehicle speed showed that going round the curve more slowly actually increases derailment risk
- improved levels of lateral restraint (i.e. track condition) would greatly reduce derailment risk
- a check rail would be a highly effective means of preventing derailment in this situation

- although lower wheel / rail friction would reduce derailment risk, the reduction required to prevent derailment would adversely affect traction and braking performance
- replacing the heavily side-worn rails would not prevent a wheel dropping between the rails, although it would reduce the risk of subsequent flange climb
- operating the service with a more modern design of modern multiple unit would not prevent derailment under these conditions
